Mitigation of Glass Hazards in High Threat Environment using Cable Catch Systems

November 2, 2018

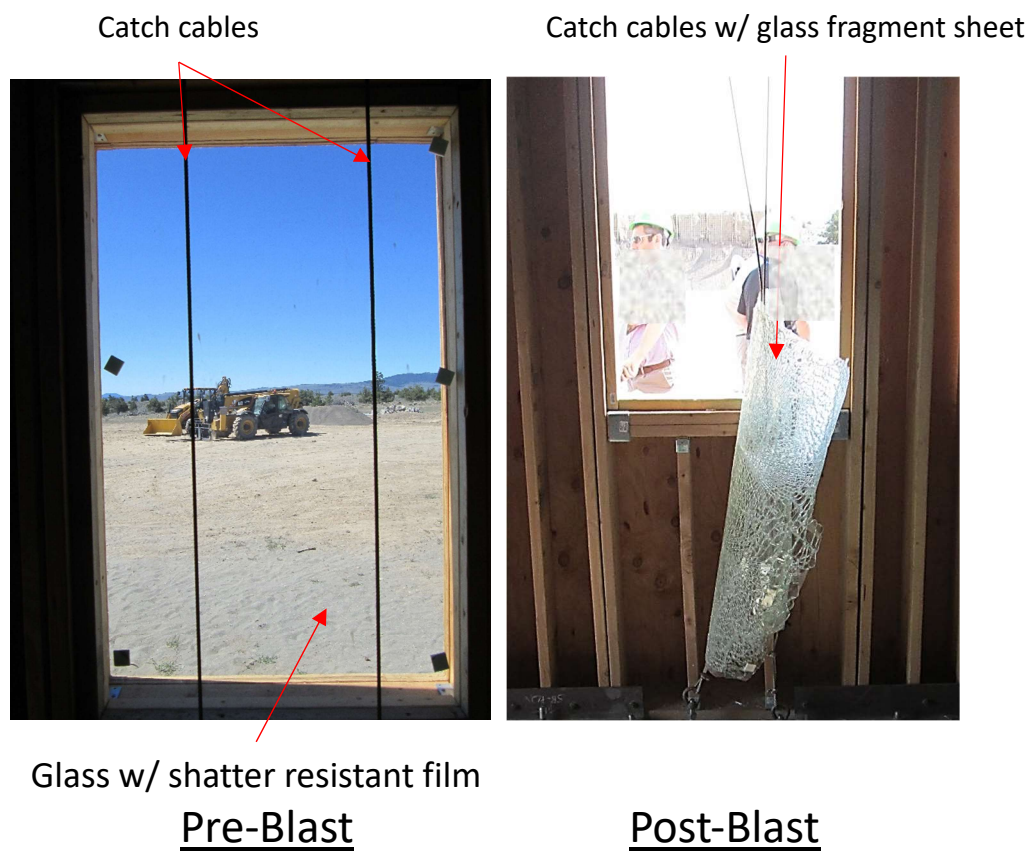
Figure 2 shows a CCS before and after a blast event. At first glance, the post-blast photo appears to show significant damage; however, this response is considered successful protection. The

reason is two-fold: 1) the SRF retained most of the glass fragments on a single sheet and 2) the fragment sheet wrapped around the catch cables rather than flying into the occupied space. In addition, the cables can be designed to catch the window frame in addition to the glass fragment sheet.

Figure 2. Cable Catch System Example Pre-Blast and Post-Blast

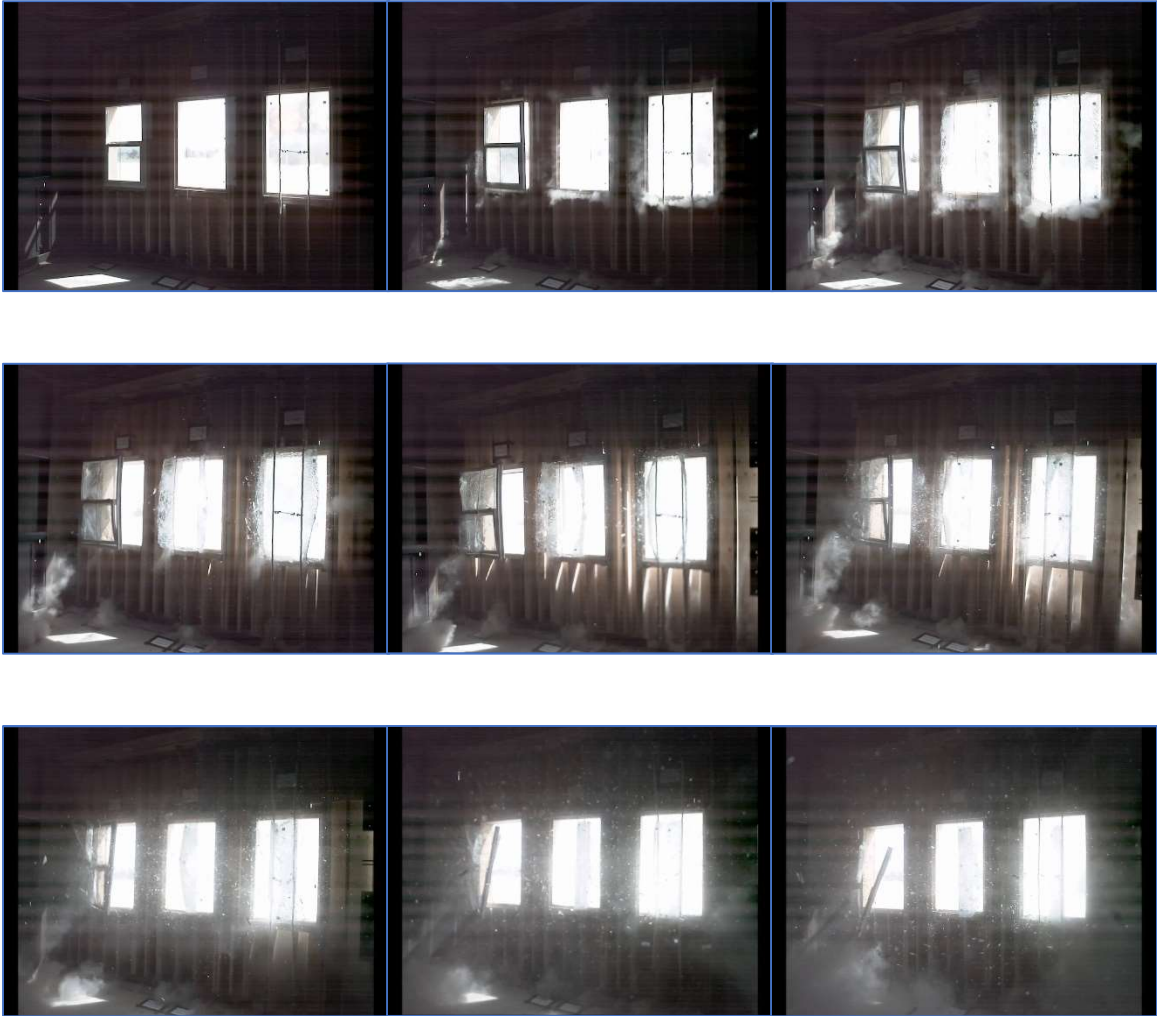
The results of the demonstration are described below. Figure 5 shows screenshots from high-speed video taken during the explosion. For Window 1, the window glass and frame projected into the room and were caught by the single $\frac{1}{4}$ " diameter cable. SRF was only applied to the protected side (i.e., the inner pane) of the IGU. Therefore, the inner pane glass fragments were retained by the SRF, wrapped around the cable, and fell to the floor. The outer pane did not have any SRF applied. As a result, the outer pane fragments projected into the room. In addition, the window frame projected into the room, impacted the cable, began to rotate around the cable, and fell to the floor. Figure 6 shows the post-blast response of the windows. The Window 1 fragment sheets can be seen on the ground below the Window 1 location. In addition, the wedge anchor for the Window 1 cable experienced partial pullout of approximately 3.75-in. Figure 7 shows a close-up of the anchor after the blast.

Figure 5. Cable Catch System Response Time-History (Left-to-Right, Top-to-Bottom)

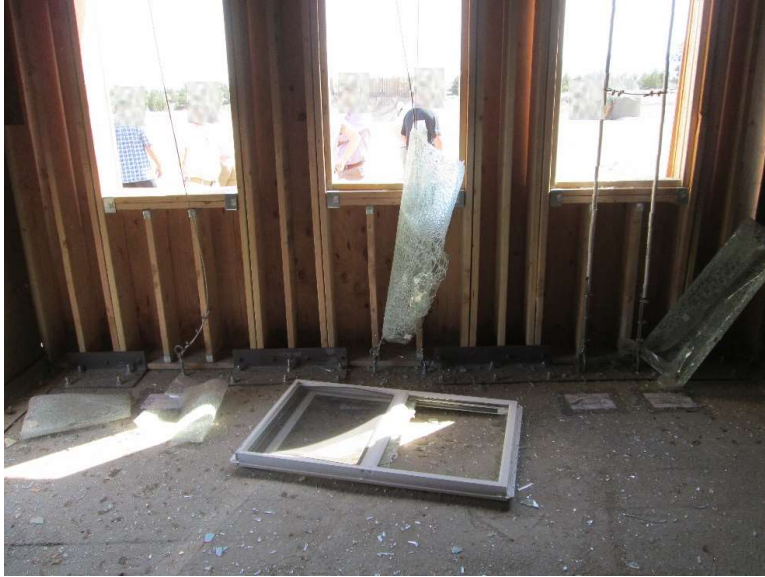
The Window 2 glass shattered upon the blast wave arrival, but the fragments were retained by the SRF. The fragment sheet projected into the room, impacted the two cables, wrapped around them, and then slid toward the floor. Figure 6 shows the Window 2 fragment sheet wrapped around the two cables behind the Window 2 location. Similar to Window 1, the anchor for one of the cables experienced a partial pullout of approximately 2-in while the other anchor did not experience any pullout. Figure 7 shows a close-up of the anchors.

Window 3 behaved similar to Window 2 except there was no anchor pullout. Figure 6 shows the fragment sheet on the floor to the right of the Window 3 location. The thimbles at the top and bottom of the Window 3 cables experienced permanent deformation due to the tension applied by the cables. The ends of the thimbles were initially spread apart by about 0.5-in, but were clamped together after the blast. Figure 8 shows before and after pictures of the thimble.

Figure 6. Post-Blast Cable Catch System Response

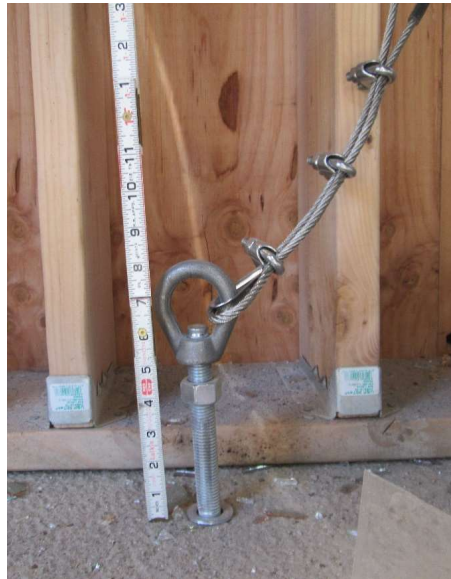
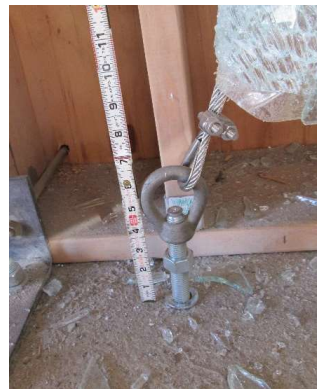
a) Window 1 Cable Anchor b) Window 2 Cable Anchors

Figure 7. Window Cable Anchor Post-Blast Response: a) Window 1 and b) Window 2

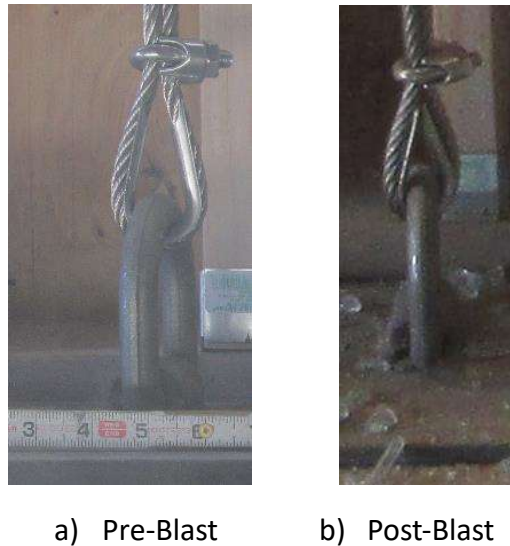
Figure 8. Window 3 Cable Thimble Permanent Deformation
