Mitigation of Glass Hazards in High Threat Environment using Cable Catch Systems

November 2, 2018

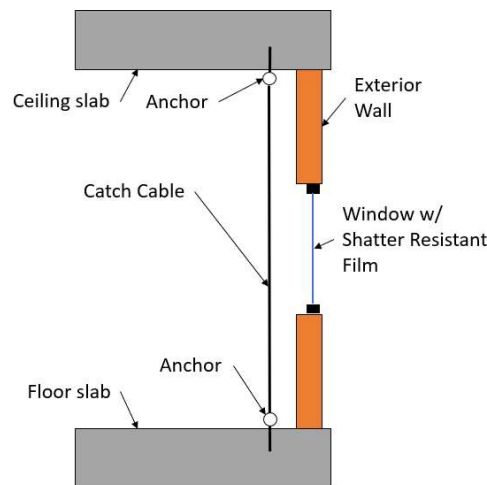
Figure 1. General Cable Catch System Layout

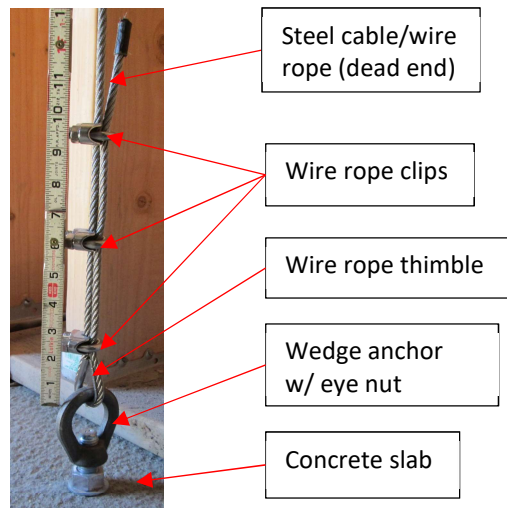
In general, the cable connections consist of the cable looping through an eye bolt/nut that is anchored to the floor or ceiling slab. The steel cable is terminated via a combination of a steel thimble at the turnback point followed by a series of wire rope clips on the dead end of the cable. Failure can occur due to the anchor pulling out or breaking, the cable splitting at the turnback point, and/or the cable slipping through the wire rope clips.

Figure 3. Cable Connection

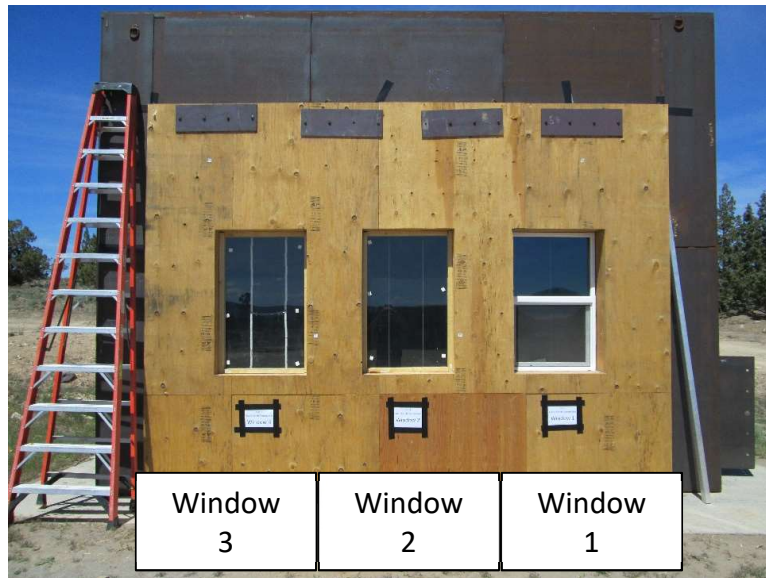
The demonstration was performed at the Stone-OBL test site outside of Bend, OR. The window systems were subjected to a 200-lb TNT equivalent charge at a standoff of 117 feet. The demonstration consisted of three (3) windows: one (1) vinyl framed window and two (2) $\frac{1}{4}$ " thick annealed glass panes. Each window opening had rough dimensions of 30-in wide by 48-in tall and was approximately 41.5-in above the concrete floor slab. Cables were located roughly 3 inches behind the three window specimens. Each window used the same 8mil thick SRF with a tensile strength of 27,000 psi. The Window 1 system was expected to fail, the Window 2 system was expected to be at the borderline of failure, and the Window 3 system was expected not to fail. Figure 4 shows an exterior photo of the demonstration test set-up.

The Window 1 catch cable consisted of a single $\frac{1}{4}$ " diameter steel cable, the Window 2 catch system consisted of two (2) $\frac{1}{4}$ " diameter steel cables, and the Window 3 catch system consisted of two (2) $\frac{3}{8}$ " diameter steel cables. Note that the cables for Window 3 were covered with $\frac{1}{2}$ " diameter schedule 40 PVC pipe segments and included a horizontal cable connecting the two (2) vertical cables at the mid-height of the window. The PVC pipe segments increased the surface area of the cables, thus reducing the chance that the cable cut the SRF upon impact. The horizontal cable was added to keep the cables from spreading apart and block the glass fragment sheet from slipping between the cables.

The floor anchors for Window 1 and Window 2 consisted of concrete wedge anchors with eye-nuts. The floor anchors for Window 3 consisted of a steel plate with D-rings welded to it and anchored to the floor slab using heavy duty expansion anchors. The ceiling anchors for each window consisted of a D-ring welded to the supporting steel structure.

Figure 4. Window Test Specimen (Exterior View)
